A36 30.4 Victoria Road Footbridge & A36 30.1 Wyndham Road Footbridge

- Technical Workshop

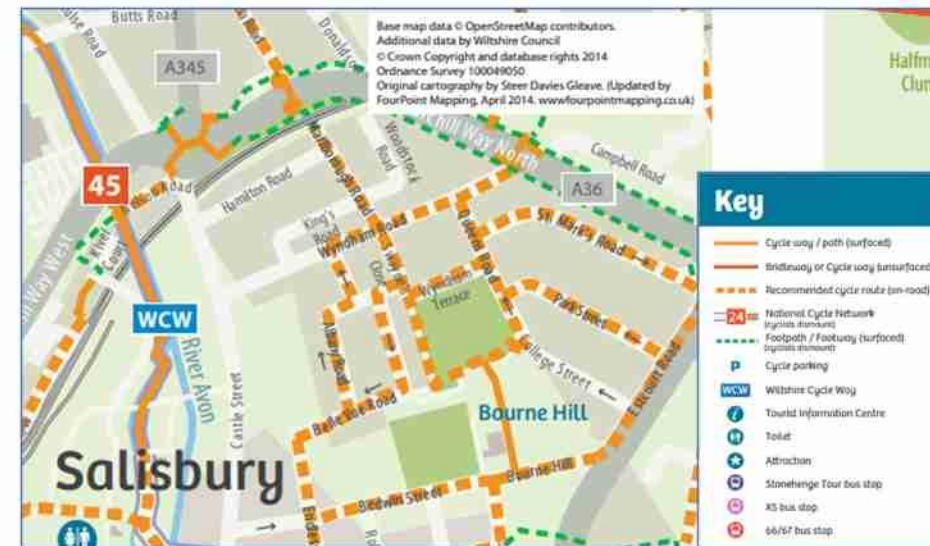
Cycling Routes

The **Victoria Road footbridge** is currently signed as and operates as a shared use path and is **well used by pedestrians and cyclists** alike. The **Wyndham Road footbridge** operates a **footway only** and is again well used.

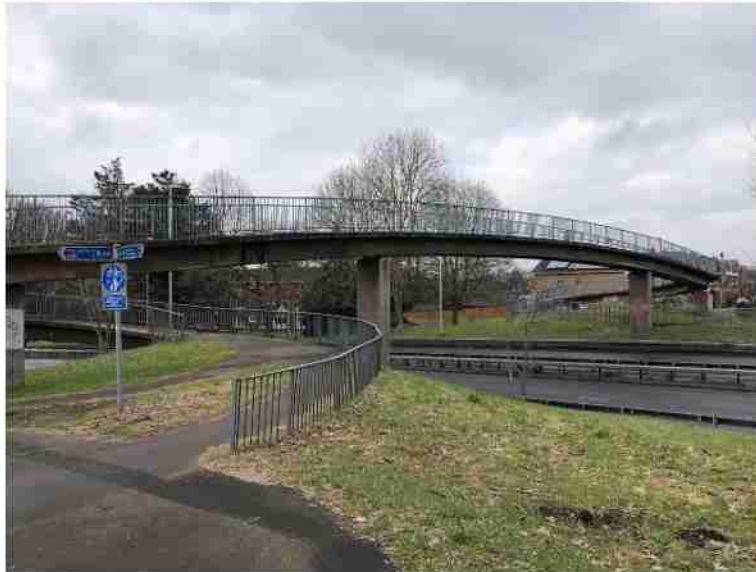
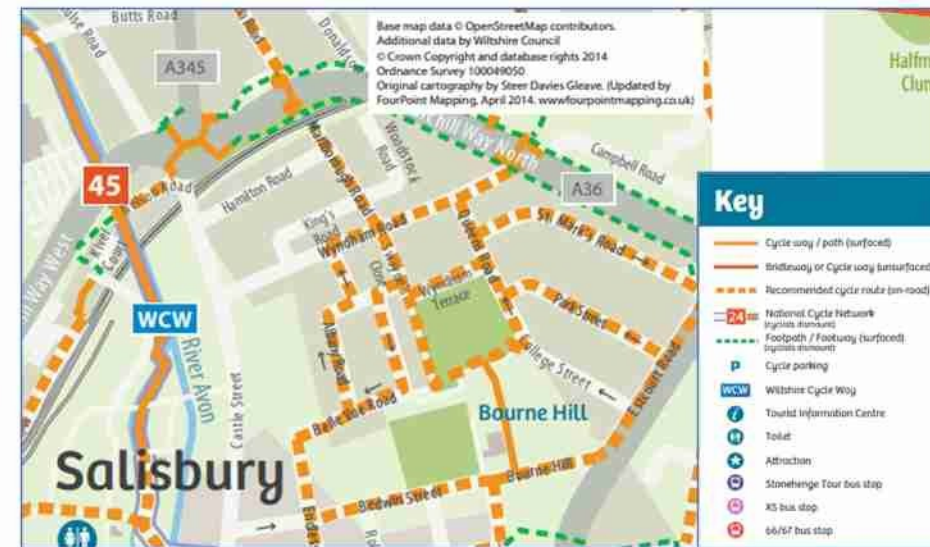
Location – WCHAR

The combined usage sign at Victoria Road Footbridge was installed not in conjunction with National Highways.

There is no signage at Wyndham Road Footbridge

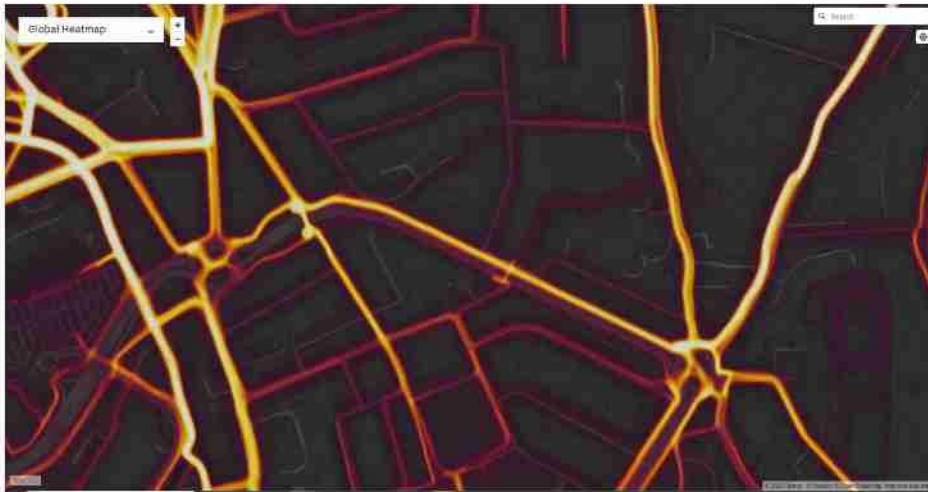
■ Walking

Location – STRAVA Heatmaps

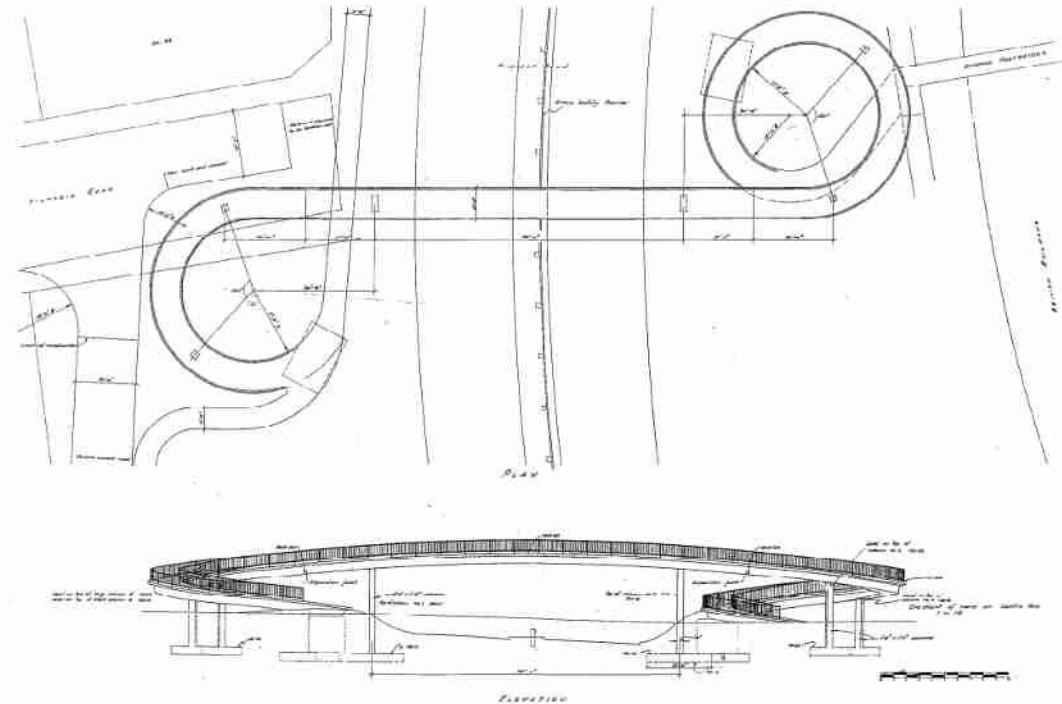
Victoria Road Footbridge – As-Built

- Constructed in 1968 of reinforced concrete beams with transverse cantilevers carrying parapets
- Main span is continuous over the columns
- Spiral ramps at each end with 3No. deck units
- 2No. intermediate rectangular reinforced concrete piers supporting the main span, 2No. square reinforced concrete piers per ramp
- Minimum headroom clearance: 5.02m
- Signed head room: 4.8m
- Width: 2.44m

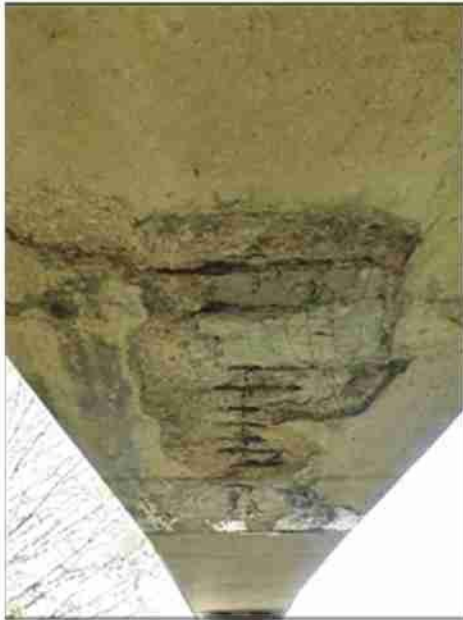
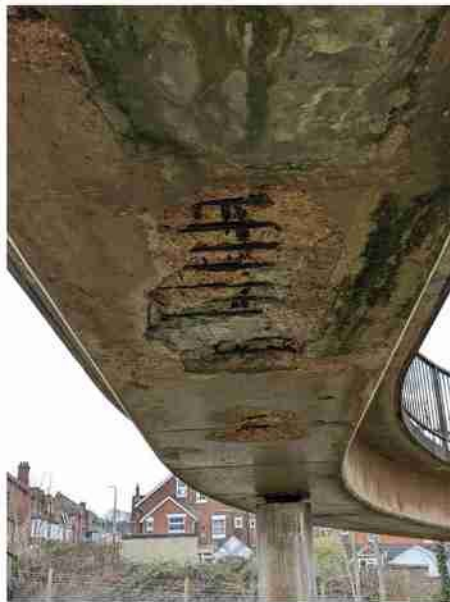
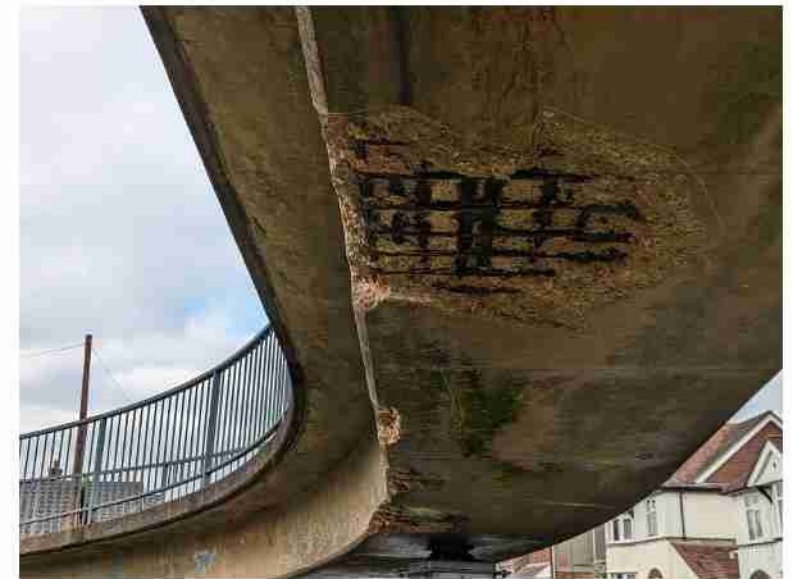
Victoria Road Footbridge – Condition

- Cracking, spalling and delamination of the soffit and piers with exposed corroding reinforcement
- Failed concrete repairs

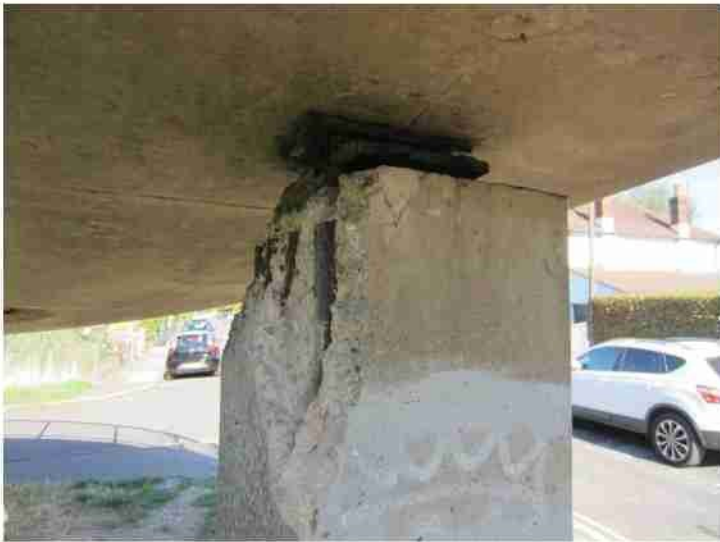
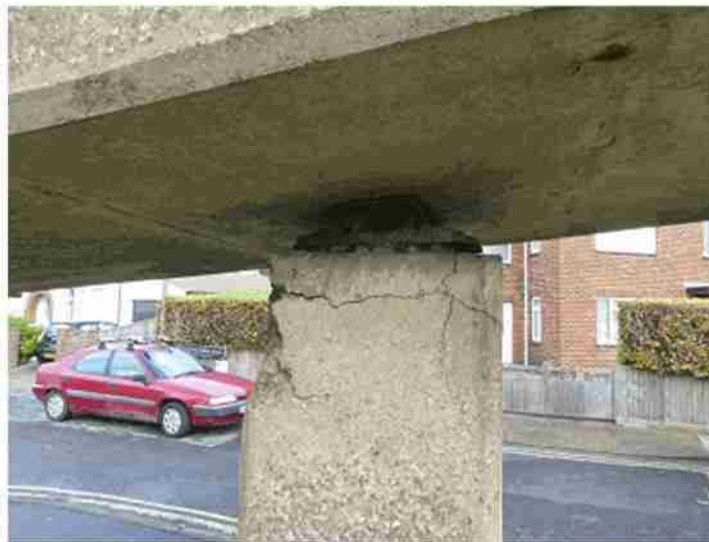
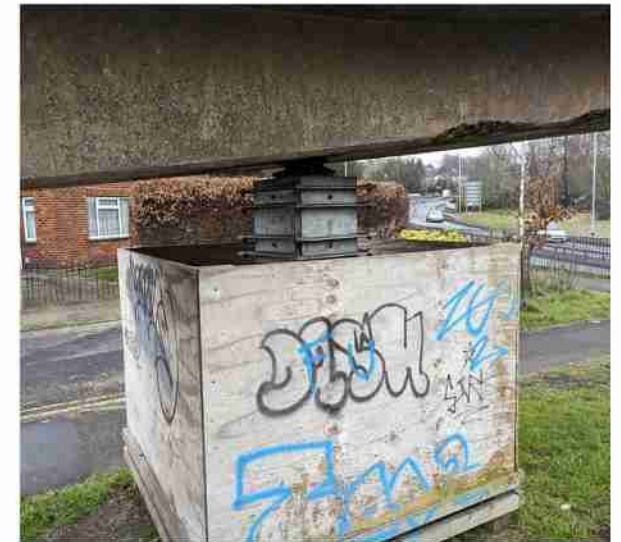
Victoria Road Footbridge – Condition

- Pier 2, north ramp column
 - Cracking present in top of pier 2, with significant corrosion to exposed rebar
 - Steel collar installed

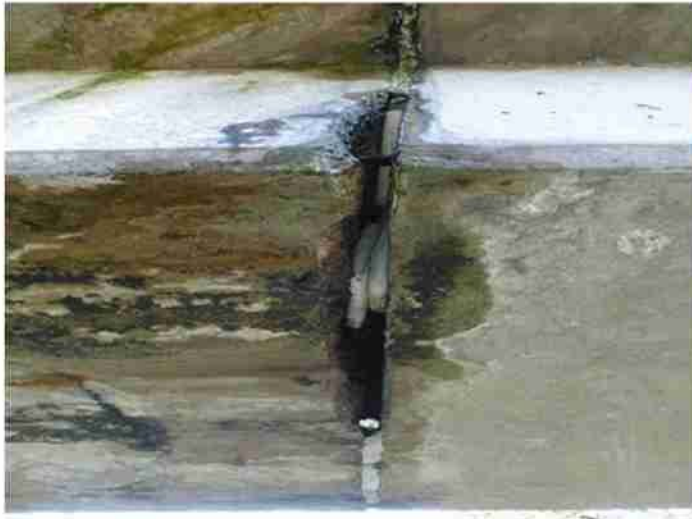
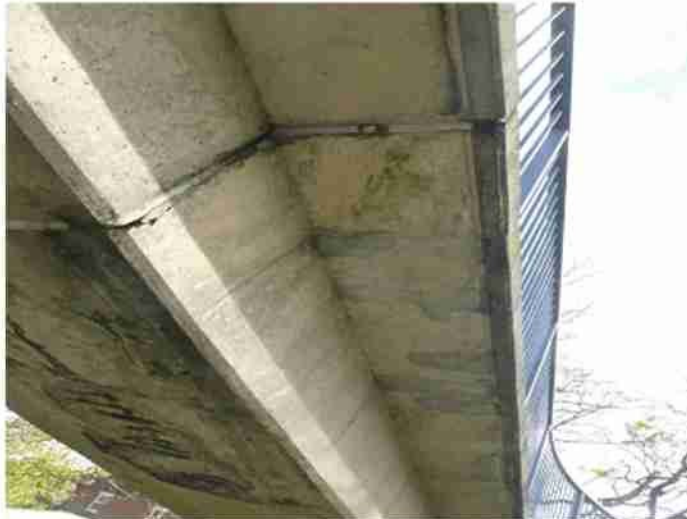
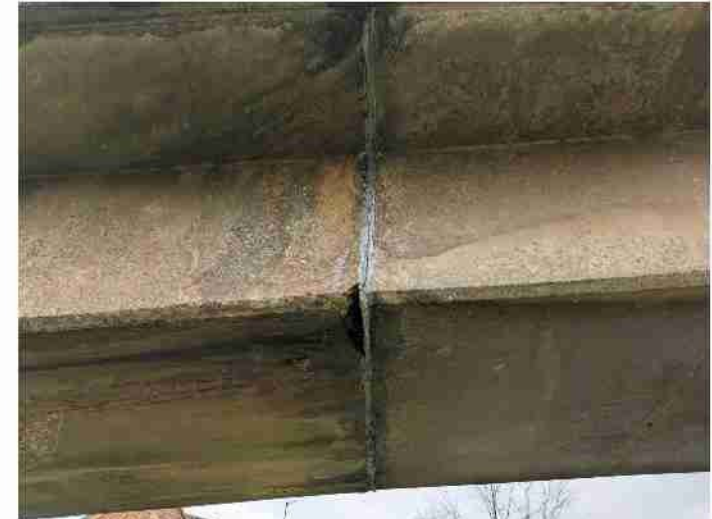
Victoria Road Footbridge – Condition

- Failed and leaking expansion joints

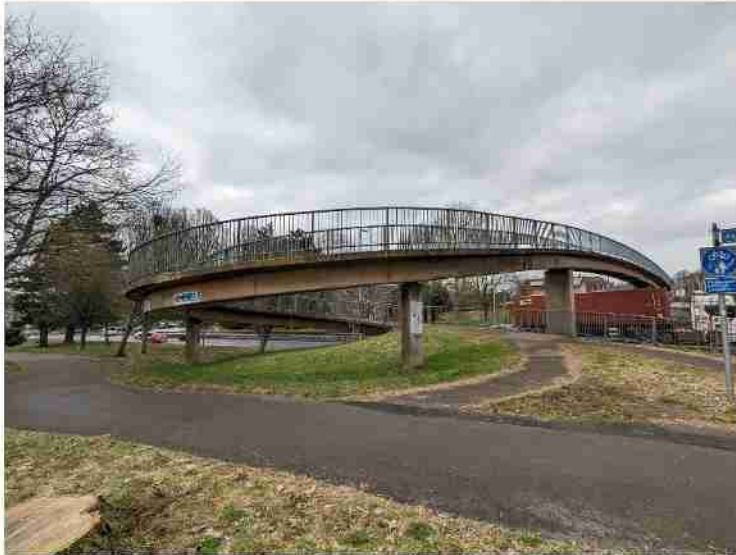
Victoria Road Footbridge – Requirements

- Substandard headroom – 5.02m
- Substandard deck width – 2.44m
- Substandard parapet height – 1.07m
- Existing ramps are steeper than the maximum gradient of 1 in 12m

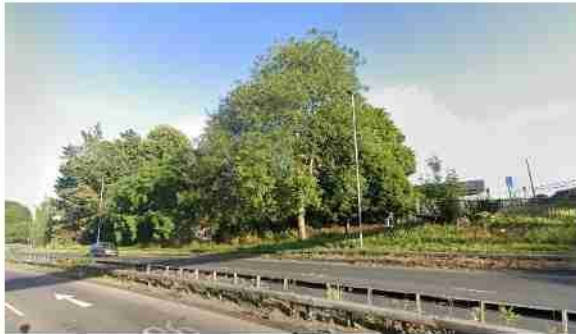
Looking North

- Demolishing the existing bridge
- Removal of 16 mature trees
 - WSP Arboriculture report concluded there were no TPOs in place
- Potential adverse effects of screening to the adjacent flats

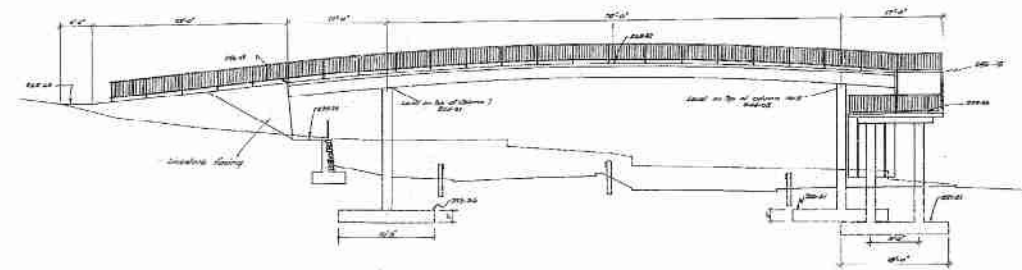
SECTION A-A

- Constructed in 1968 of reinforced concrete beams with transverse cantilevers carrying parapets
- Main span is continuous over the columns
- 2No. intermediate piers comprising reinforced concrete raked slab wall
- 5No. Span ramp structure at the south end with 4No. Square concrete piers
- Mass concrete abutment at the north end
- Minimum headroom clearance: 4.98m Southbound Lane 2
- Signed headroom: 4.8m
- Width: 2.15m

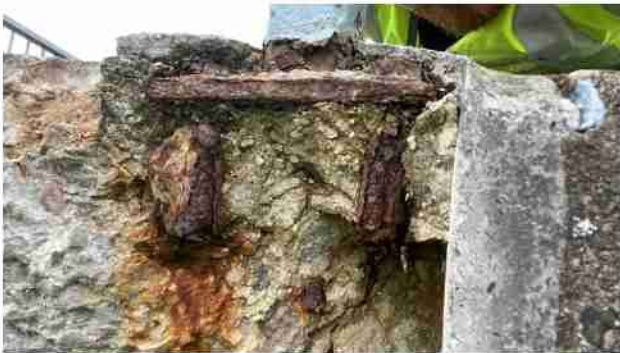
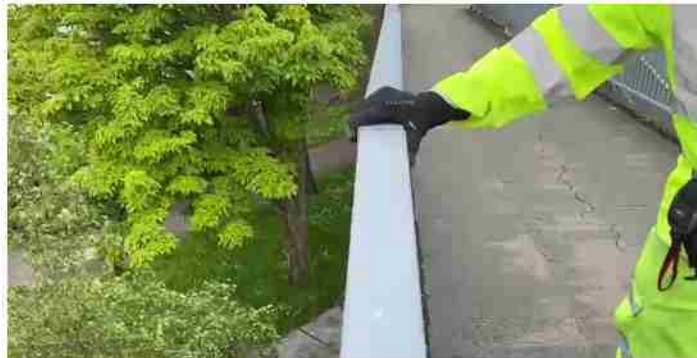
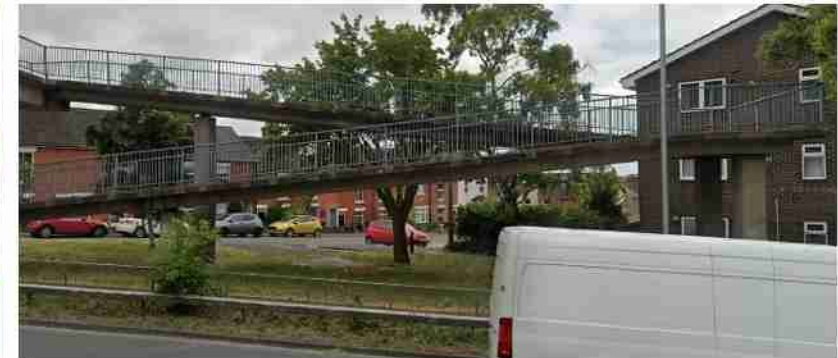
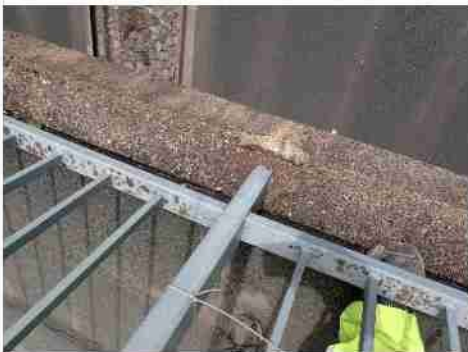
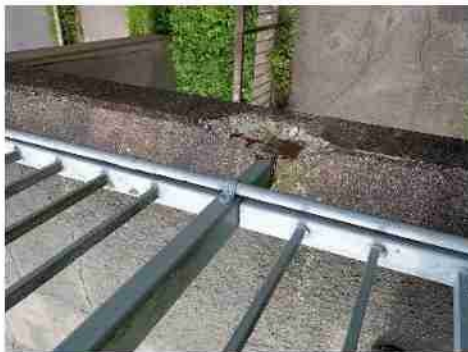
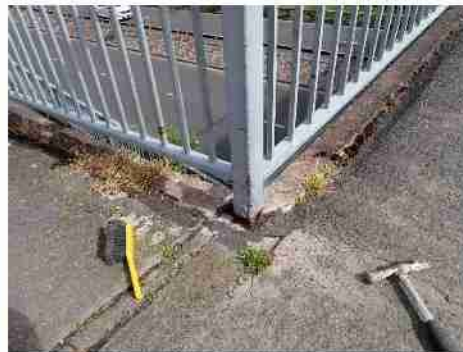
■ Parapets

- Following inspection by National Highways the bridge was closed due to the poor condition of the parapet connection **causing a safety risk to pedestrians**

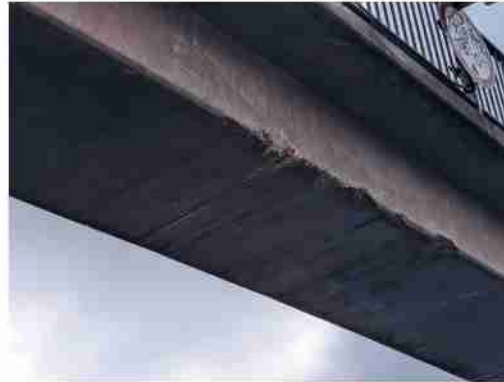
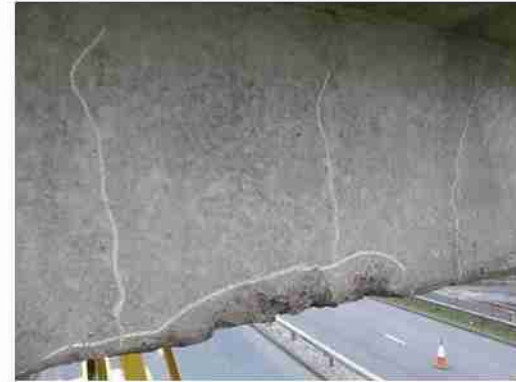
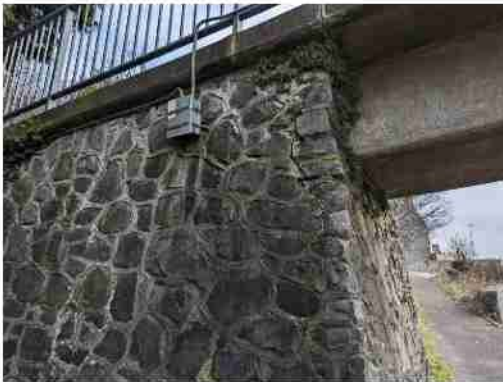
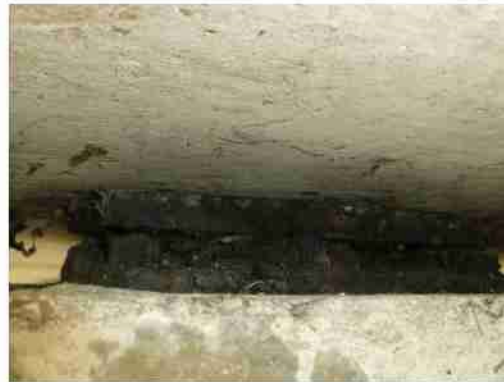
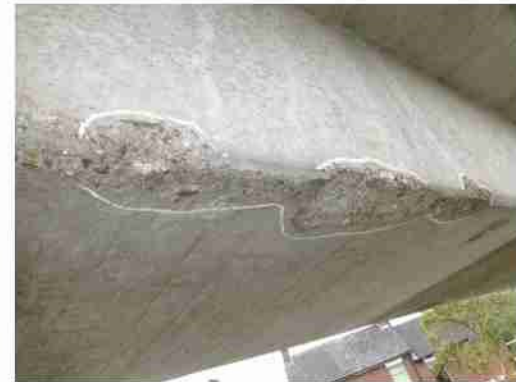
Wyndham Road Footbridge – Condition

- Vehicle impact damage
- Bearing corrosion
- Concrete deterioration
- Cracking to north abutment masonry face

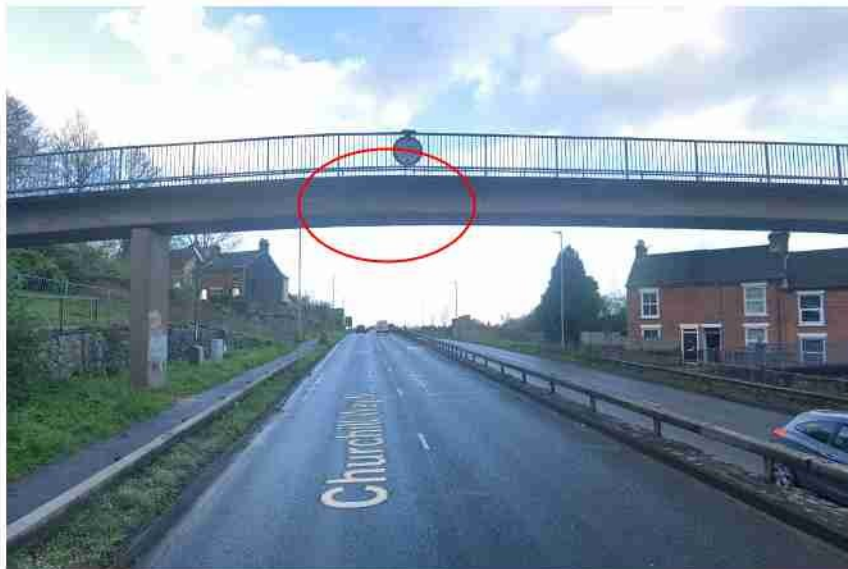
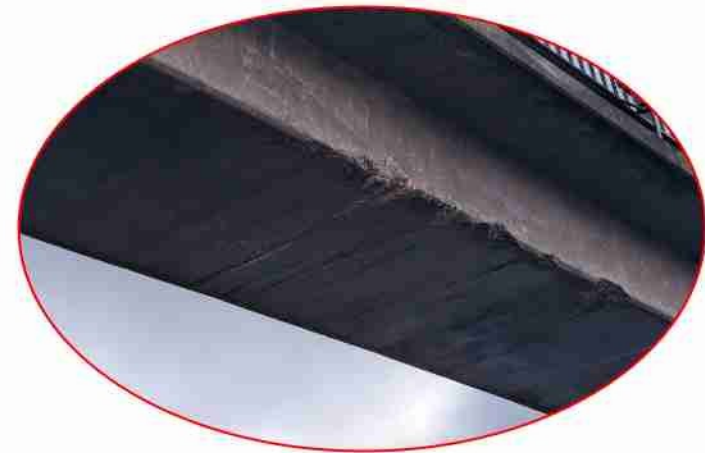
Wyndham Road Footbridge – Requirements

- Signed 4.8m
- Measured headroom – 4.98m
- Required $5.70\text{m} + S$
- Bridge strike damage to deck above east bound lane 1

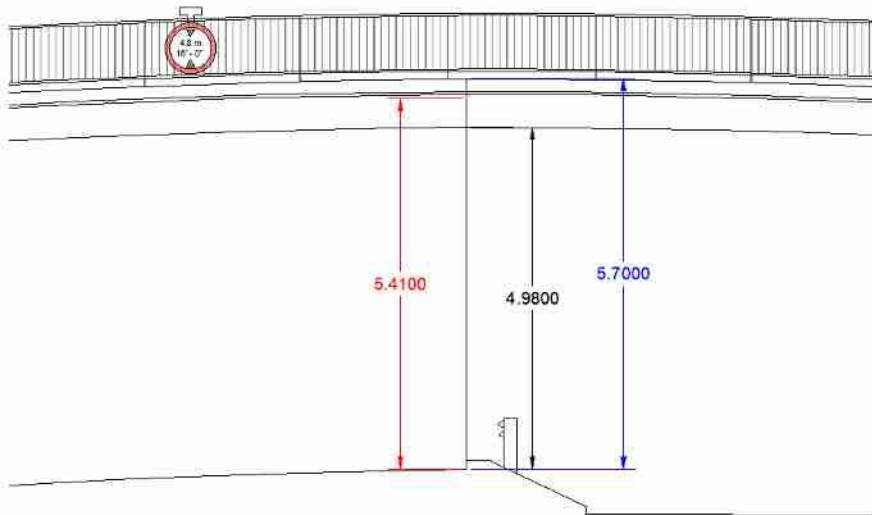
Wyndham Road Footbridge – Requirements

- Substandard headroom – 4.98m
- Construction depth: 2' 6" = 0.762m
- Top of surfacing – 5.73m

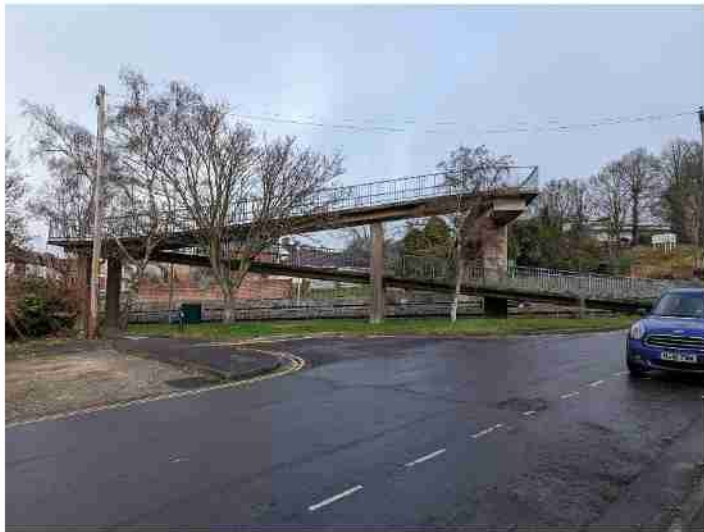
Wyndham Road Footbridge – Requirements

- Substandard deck width – 2.13m
- Substandard parapet height – 1m
- Existing ramps are steeper than the maximum gradient of 1 in 12m

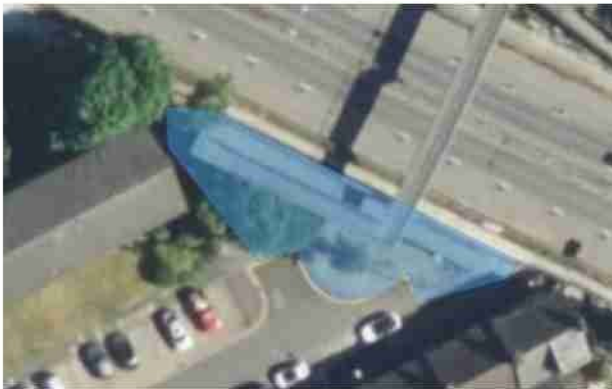
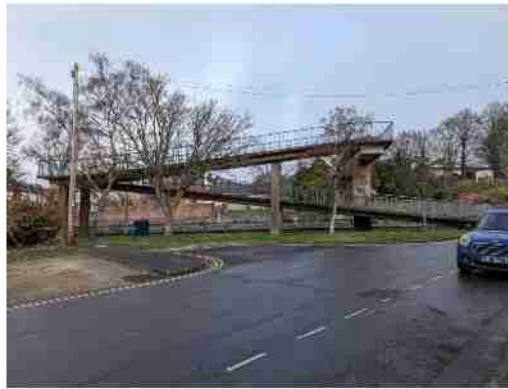
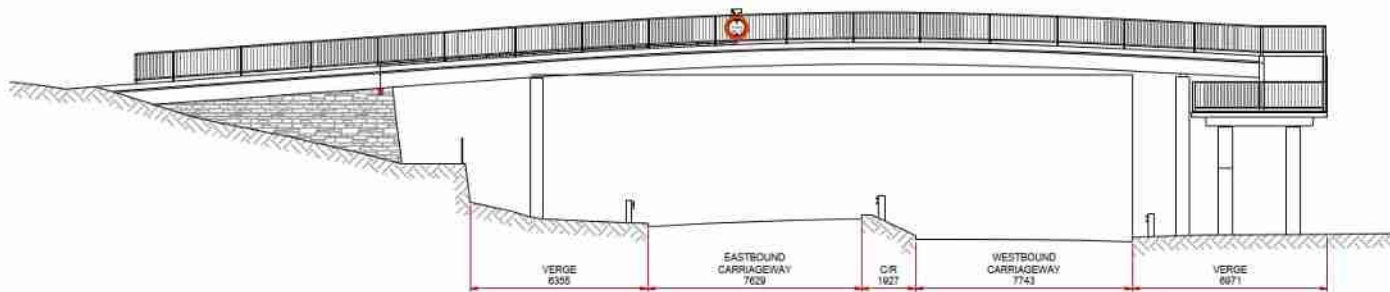
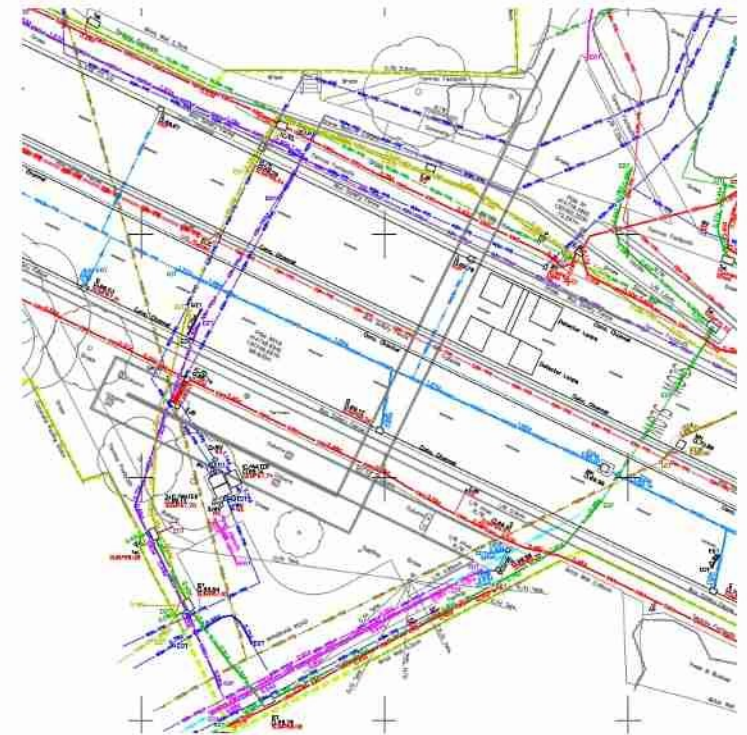
Wyndham Road Footbridge – Replacement

- Arrangement of the south ramp
 - Length of ramps are required to be 30m longer than existing
 - Width of deck to be wider for combined pedestrian cycle
 - Services within the ground

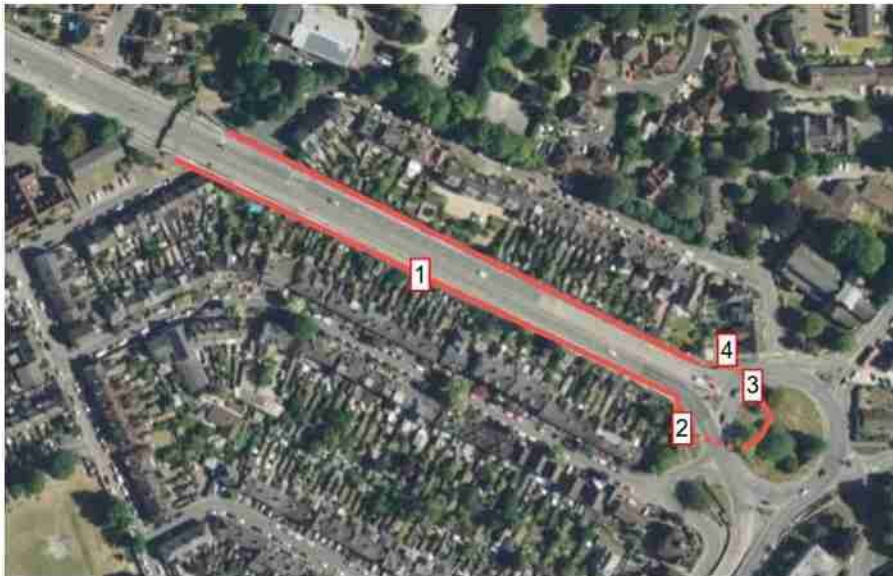
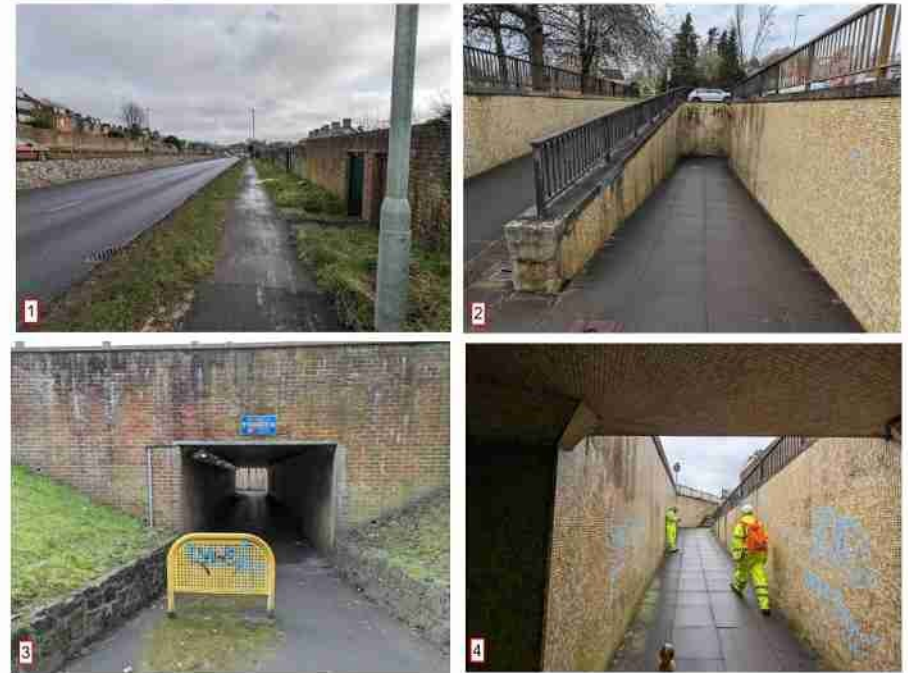
Wyndham Road Footbridge – Preferred Option

- Demolish the existing structure, divert footfall to subway ~600m

- Improvements to subway
- Improved access at Victoria Road Footbridge

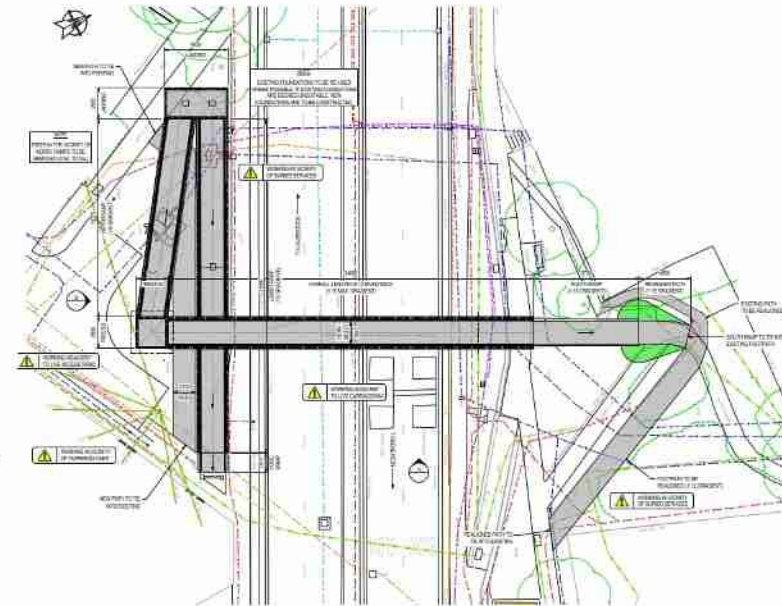
■ Bridge Non-Compliant Replacement:

- Demolishing the existing bridge and constructing a new steel footbridge with minor changes to the existing footprint
- 5No. Trees without TPO to be removed.
- Compliant headroom for a new structure 5.7m
- Compliant 2.15m clear width for pedestrian only footpath
- Ramp access with maximum 31m length with non-compliant 1:9 gradient to match the existing
